Application Examples of TLH Roller Chain

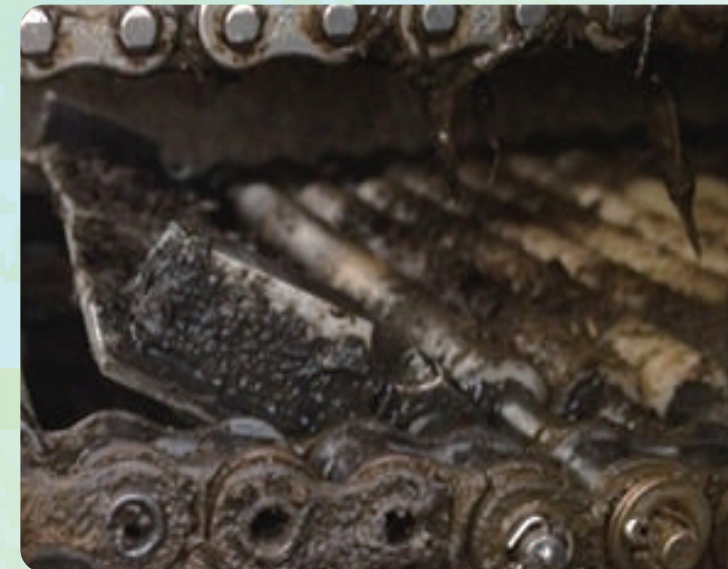
Industry: Food Industry

Equipment: Vegetable transfer line

Use Environment: Muddy water

Exposed to muddy water, the stainless steel chains elongated quickly due to wear and were subject to maintenance four times a year. The conventional stainless steel chains were replaced with TLH Roller Chain, which went beyond one year without maintenance.

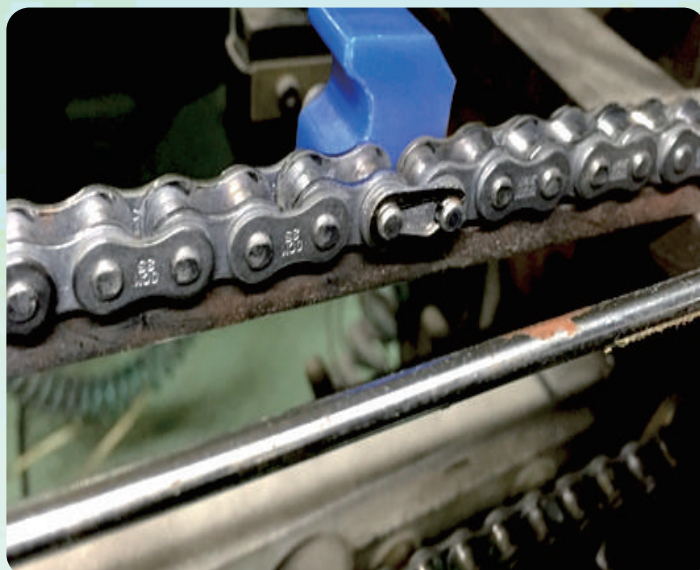
Industry: Papermaking Industry

Equipment: Paper packaging line

Use Environment: Paper dust atmosphere without lubrication

Degreased chains were used to transfer paper so that no oil would attach to the product. However, the degreased chains rusted, and the rust attached to the paper. By adopting a non-lubricated TLH Roller Chain, the problem never recurred.

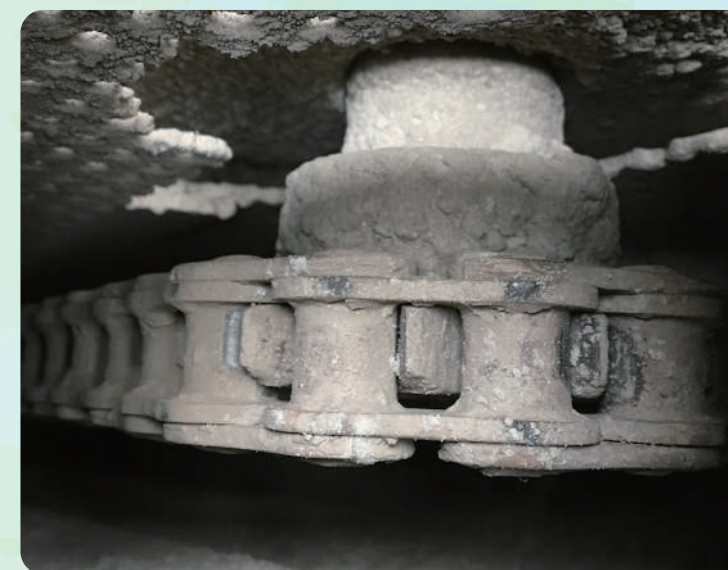
Industry: Fertilizer Industry

Equipment: Chemical fertilizer transfer system

Use Environment: Fertilizer powder scatter

Chemical fertilizer dust, made of nitrogen, phosphate, and potassium, accumulated on the chains, which rusted and reached the service limit in half a year. TLH Roller Chain did not reach the service limit even after 19 months of use without maintenance.

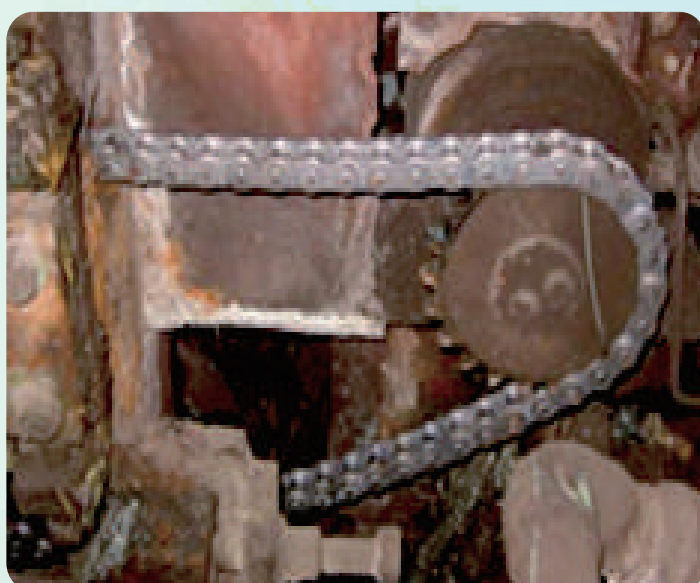
Industry: Steel Industry

Equipment: Iron-making line

Use Environment: Vapor and Dust atmosphere

In a high-temperature of 200°C to 400°C (392°F to 752°F) environment, where the chains were exposed to dust containing iron oxide vapor, the conventional standard chain had a usable life of only one year. TLH Roller Chain was adopted, extending the service limit beyond one year.

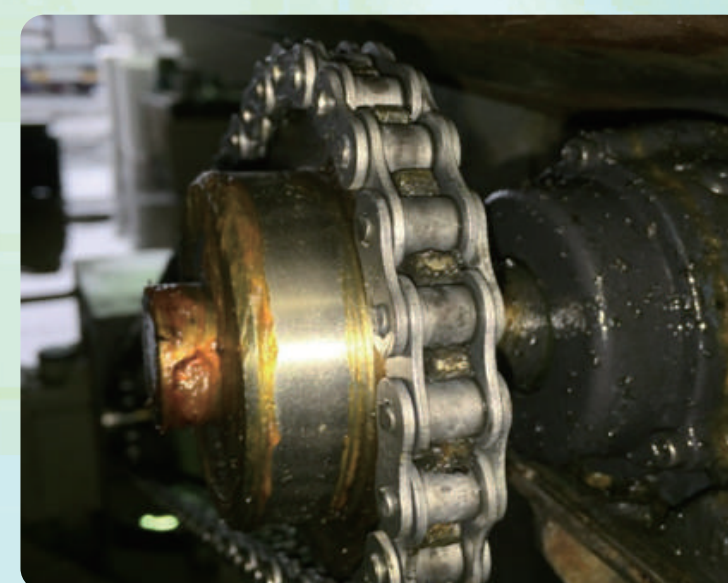
Industry: Fisheries Industry

Equipment: Clam washing system

Use Environment: Seawater

Exposed to seawater, special stainless steel chains became worn and elongated quickly. TLH Roller Chain was adopted and did not rust, wear, or elongate, even after five months of use.
