# Monitoring after installation and Test Data

## Linen Supply Industry / Automatic wet hand towel counting and packing machine

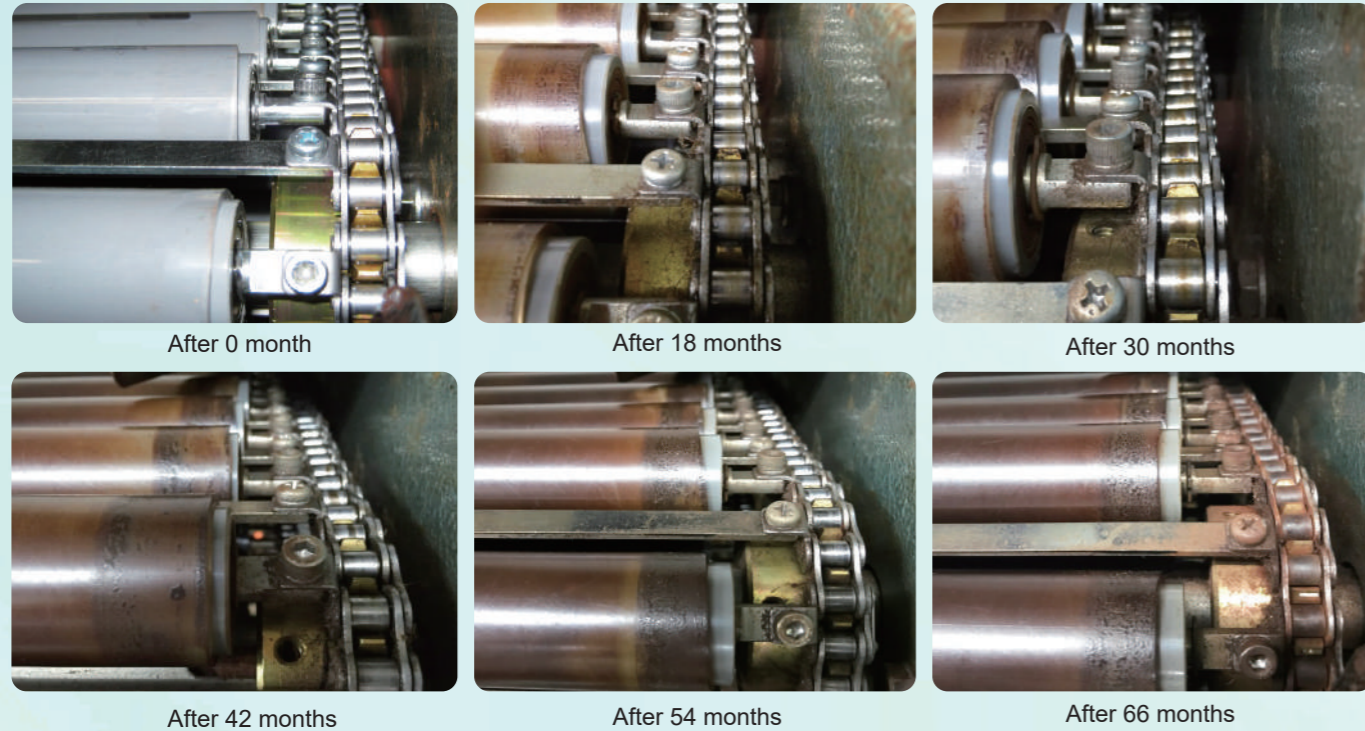
Super Shield Chain was used in a sodium hypochlorite environment, rusting in six months or so, which was a problem. It was replaced with TLH Roller Chain, which did not rust after 54 months of use and is still operating normally even after 66 months of use.

- Sodium hypochlorite environment  
Chlorine gas is generated if a mild acidic solution, with strong bactericidal power, is used.

Super Shield Chain - After 12 months

TLH Roller Chain - After 66 months

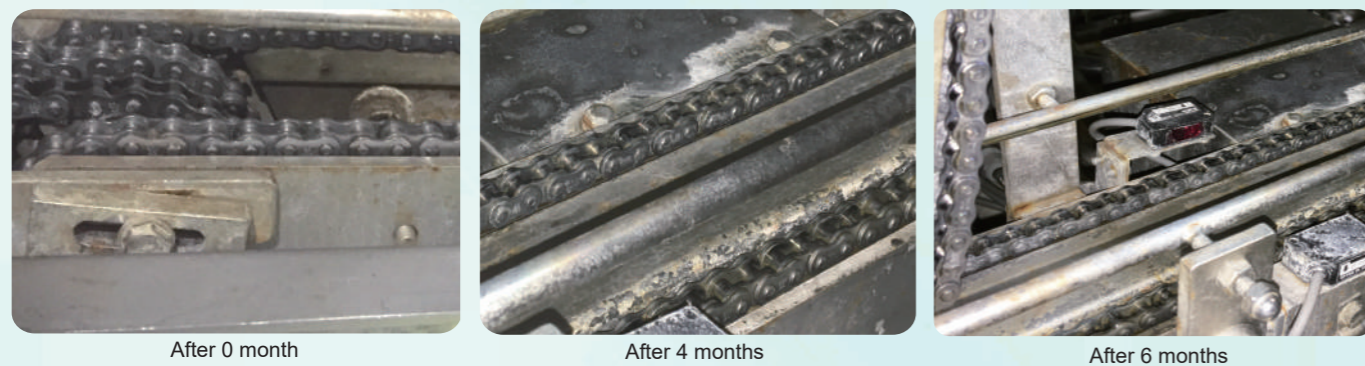
Stainless steel chains were used for the beverage filling system but they wore and elongated quickly, which was a problem. They were replaced with TLH Roller Chain, which has not elongated or rusted, even after six months of use without maintenance

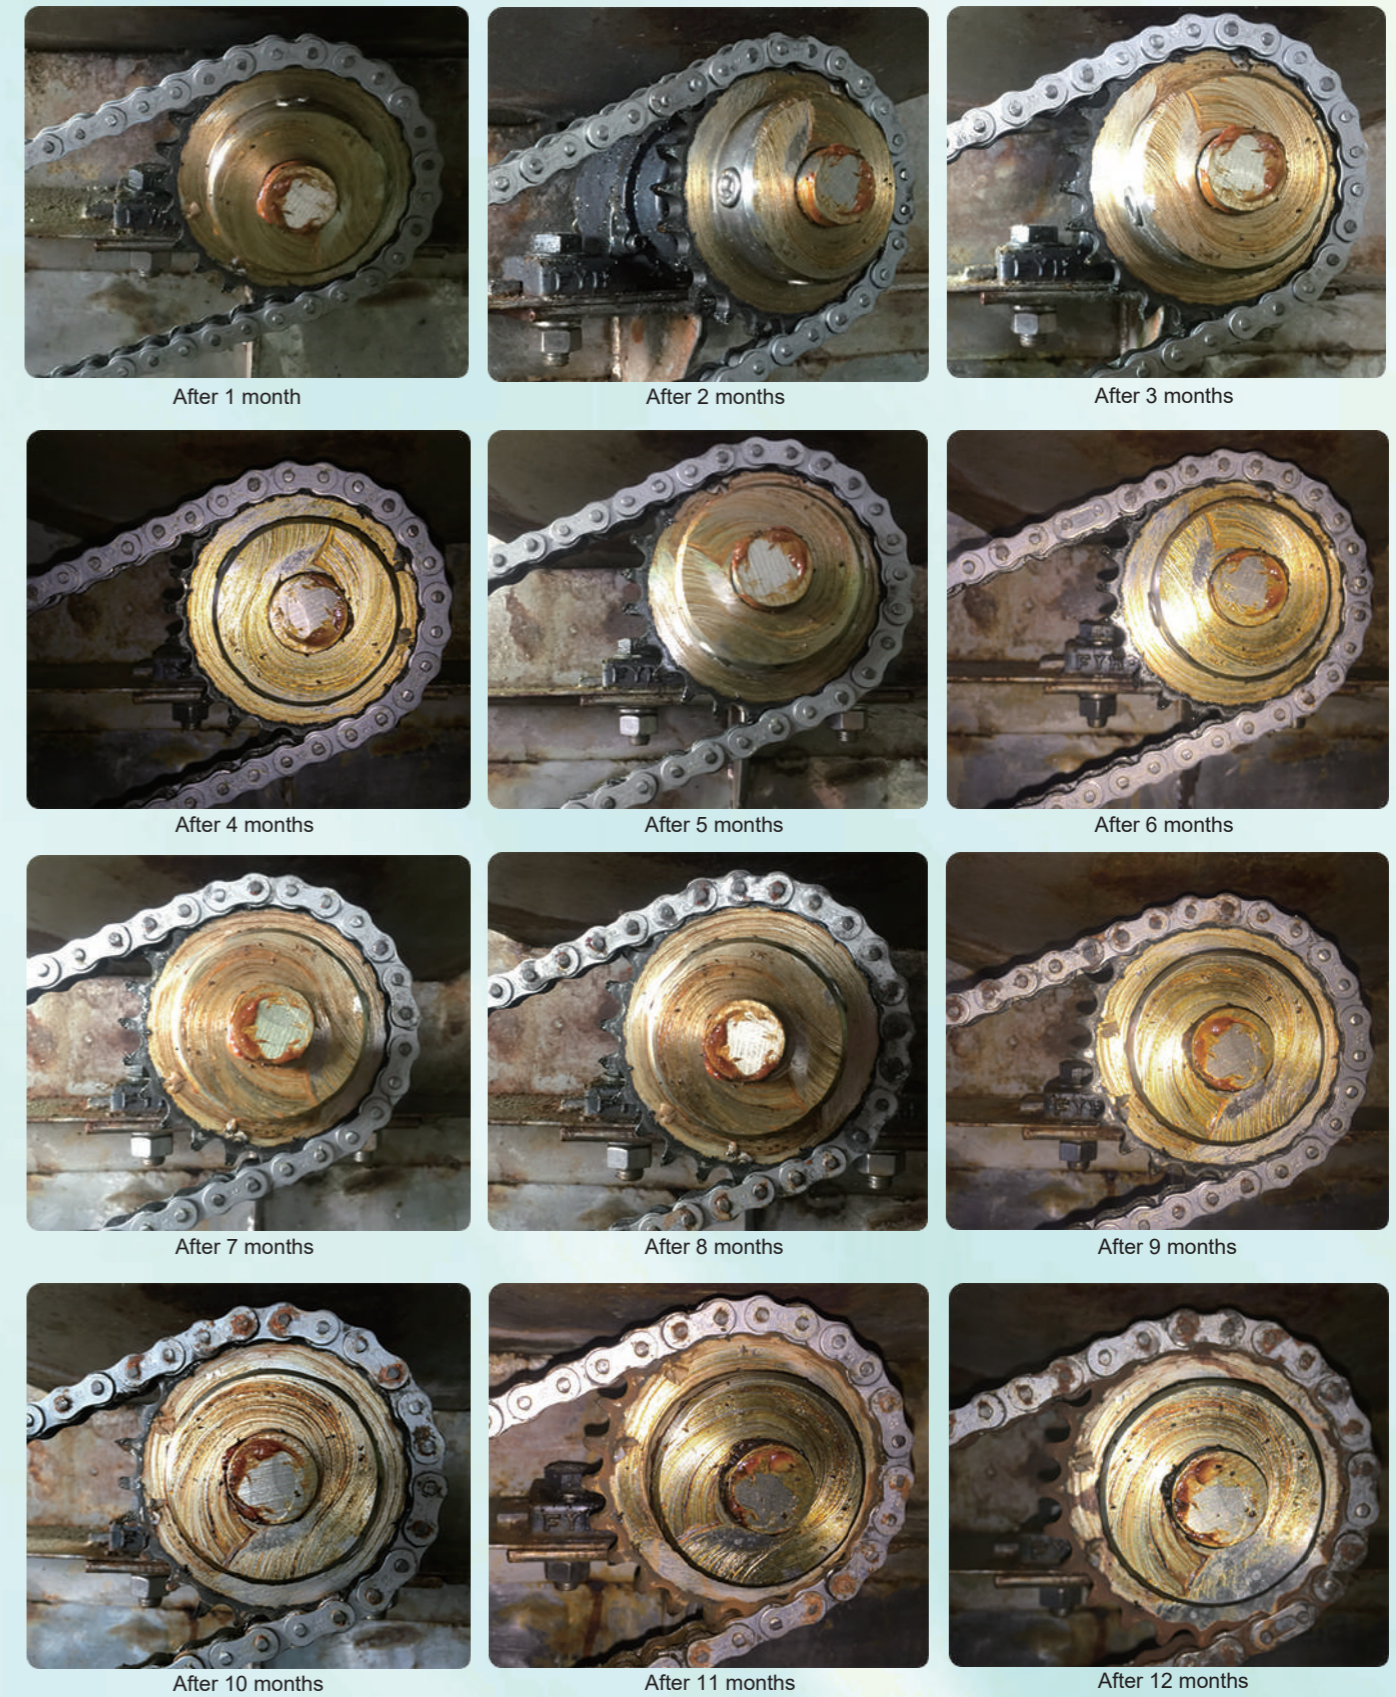
Under the clam seawater washing process stainless steel chains wore and elongated quickly, which was a problem. This problem did not recur after the chains were replaced with TLH Roller Chain.
