Internal Test Results

Stainless steel chain rollers were placed in beakers filled with a 5% sodium chloride solution. Two TLH chains were prepared. One TLH chain was immersed wholly in the solution, and the other was hung so that one-fourth of the chain length was immersed in the solution.

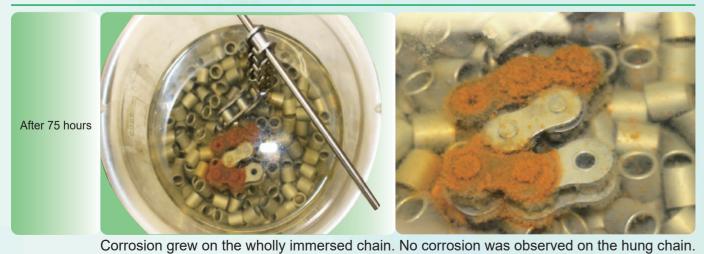
On the wholly immersed chain, corrosion started at the portions with a large contact area with the stainless steel parts. No corrosion was observed on the hung chain.

In the wholly immersed chain, electric current flew through the portions with a large contact area with the stainless steel parts, causing the TLH chain, which has excellent corrosion resistance, to corrode quickly.

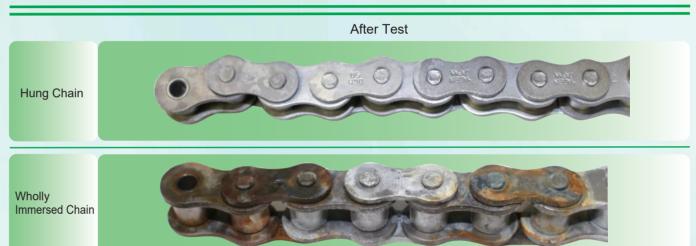
The solution became cloudy due to corrosion on the wholly immersed chain. No corrosion was observed on the hung chain.
