# TLH ROLLER CHAIN

# TLH Roller Chain has Excellent Corrosion Resistance, even under Severe Conditions.

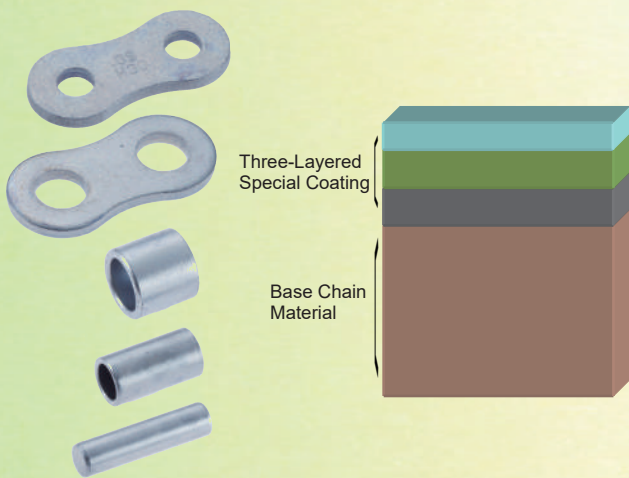
## CONSTRUCTION OF SURFACE COATING

The superior corrosion-resistance TLH roller chain consists of three layers of special coating. Each layer blocks water and oxygen, thereby preventing corrosion. An interdiffusion surface is bonded tightly in the boundary between the second and third layers. This prevents red rust for a prolonged period of time. The third coat, or the top coat, has a self-repairing effect, by which the coating molecules gather around the scratch and cover it over.

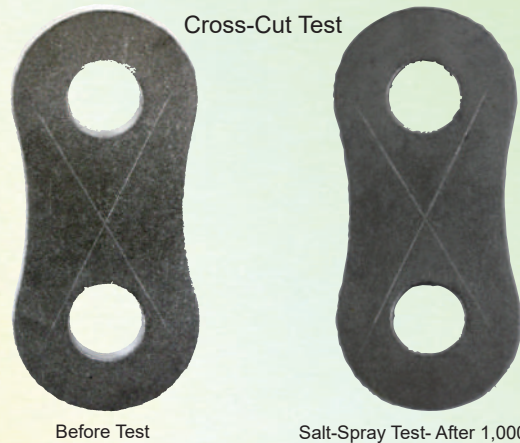
## SELF-REPAIRING PROPERTIES

Even if a scratch or crack is formed, it is covered by the special coating, thereby inhibiting rust.

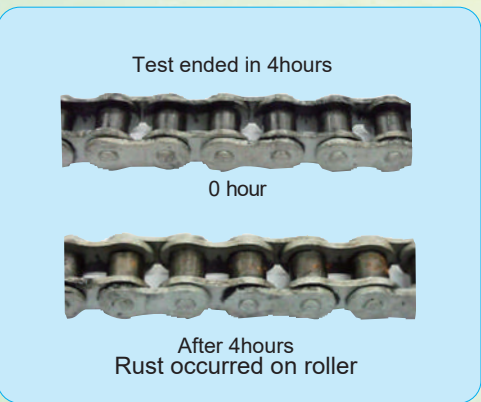
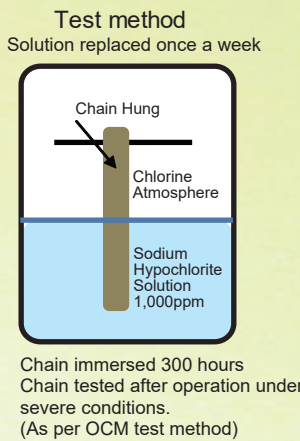
## COMPARISON OF CORROSION RESISTANCE 1. Sodium Hypochlorite Test

Internal Test result with Super Shield Chain

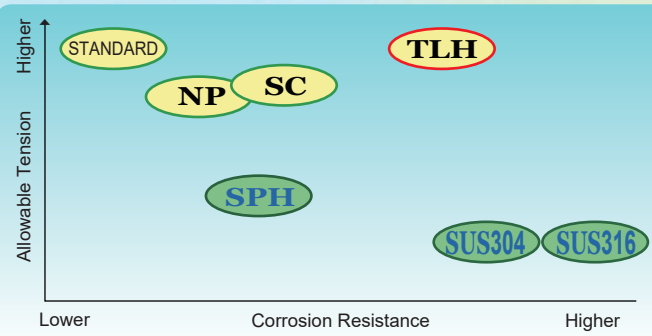
## Corrosion Resistance and Allowable Tension

Comparison between TLH Roller Chain and other models

- Standard Roller Chain  
Standard Carbon Steel
- Nickel Plated Roller Chain [NP]  
Special nickel plating is applied to each part.  
Nickel Plated Roller Chain has lower allowable tension than standard roller chain by approximately 20%.
- Super Shield Chain [SC]  
Special coating is applied to standard roller chain.  
Super Shield Chain [SC] has lower allowable tension than standard roller chain by approximately 10%.
- Stainless Steel Roller Chain [SUS]  
Stainless steel equivalent to SUS304 is used.
- Stainless Steel Roller Chain [SAC]  
Stainless steel equivalent to SUS316 is used.
- Stainless Roller Chain [SPH]  
Precipitation-hardened stainless steel is used for the pins, bushings, and rollers. The plates are SUS304 or equivalent.

TLH chain provides no decrease in allowable tension, as low coating temperature does not affect the hardness of parts.

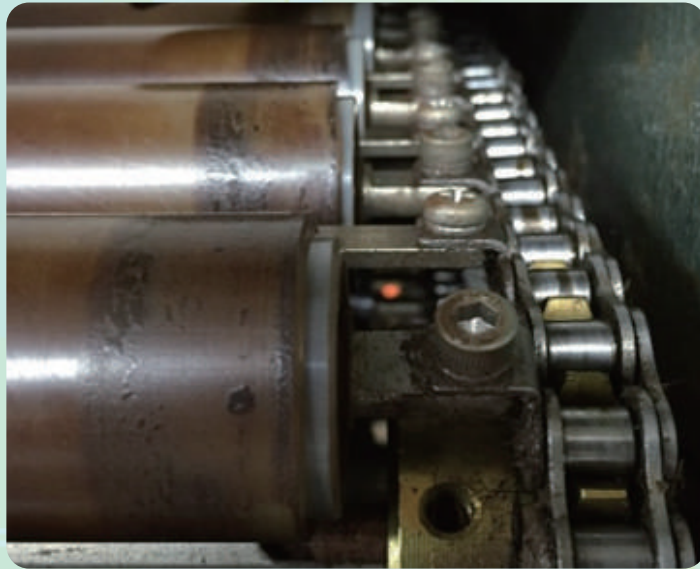
**Industry: Linen Supply Industry**

**Equipment: Automatic wet hand towel counting and packing machine.**

**Use Environment: Chlorine gas**

Rust was generated from Super Shield Chain used in one year of chlorine gas atmosphere. The rust flakes caused the air conditioner to break down. After replacing to TLH Roller Chain, the chain has not been rusted for three plus years and the air conditioner has not broken down since.

Super Shield Chain was used in a sodium hypochlorite environment, rusting in six months or so, which was a problem. It was replaced with TLH Roller Chain, which did not rust after 54 months of use and is still operating normally even after 66 months of use.

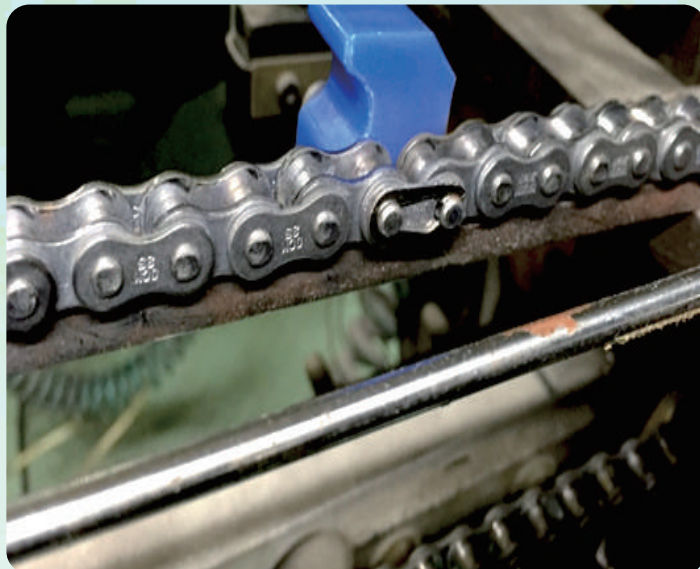
**Industry: Papermaking Industry**

**Equipment: Paper packaging line**

**Use Environment: Paper dust atmosphere without lubrication**

Degreased chains were used to transfer paper so that no oil would attach to the product. However, the degreased chains rusted, and the rust attached to the paper. By adopting a non-lubricated TLH Roller Chain, the problem never recurred.

In the paper packaging line, the degreased chains were used so that they were free of oil or paper dust, but they rusted, causing a problem. They were replaced with TLH Roller Chain, which has not rusted even after 13 months of use.

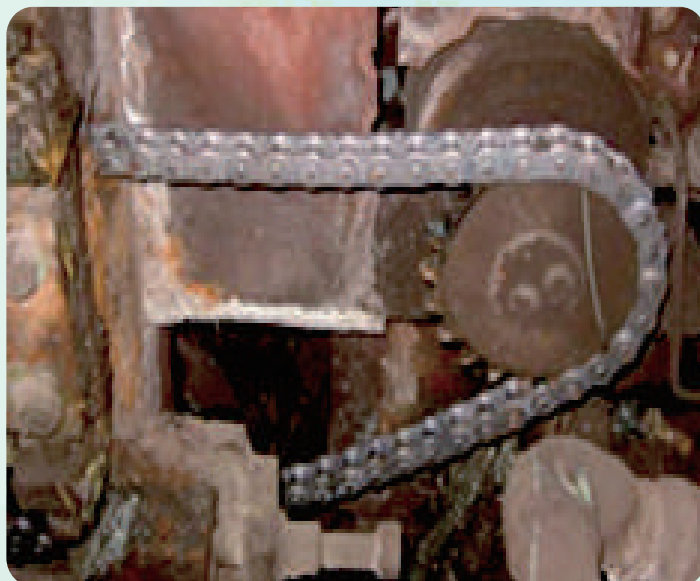
**Industry: Steel Industry**

**Equipment: Iron-making line**

**Use Environment: Vapor and Dust atmosphere**

In a high-temperature of 200°C to 400°C (392°F to 752°F) environment, where the chains were exposed to dust containing iron oxide vapor, the conventional standard chain had a usable life of only one year. TLH Roller Chain was adopted, extending the service limit beyond one year.

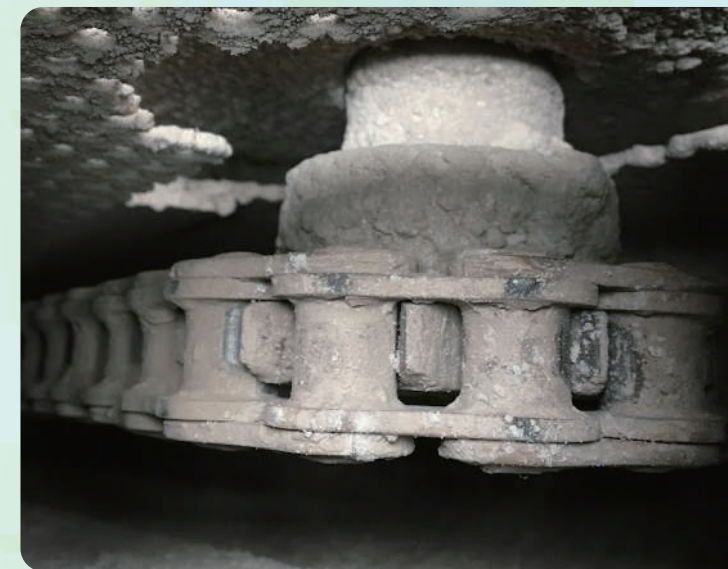
**Industry: Fertilizer Industry**

**Equipment: Chemical fertilizer transfer system**

**Use Environment: Fertilizer powder scatter**

Chemical fertilizer dust, made of nitrogen, phosphate, and potassium, accumulated on the chains, which rusted and reached the service limit in half a year. TLH Roller Chain did not reach the service limit even after 19 months of use without maintenance.

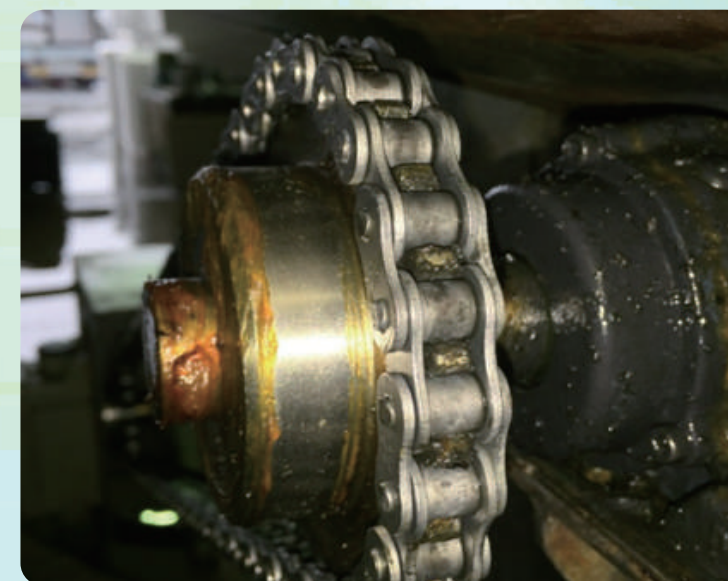
**Industry: Fisheries Industry**

**Equipment: Clam washing system**

**Use Environment: Seawater**

Exposed to seawater, special stainless steel chains became worn and elongated quickly. TLH Roller Chain was adopted and did not rust, wear, or elongate, even after five months of use.

Under the clam seawater washing process stainless steel chains wore and elongated quickly, which was a problem. This problem did not recur after the chains were replaced with TLH Roller Chain.

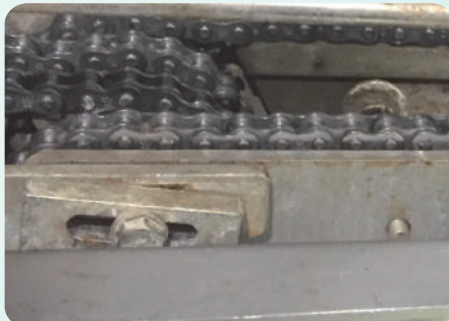
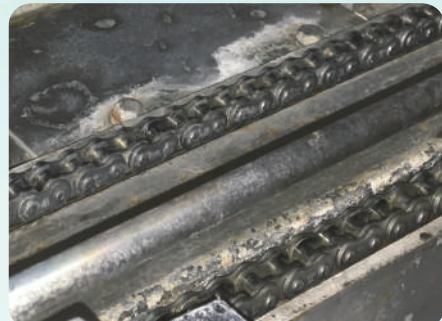
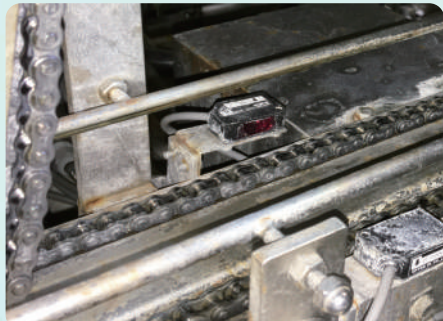
Stainless steel chains were used for the beverage filling system but they wore and elongated quickly, which was a problem. They were replaced with TLH Roller Chain, which has not elongated or rusted, even after six months of use without maintenance

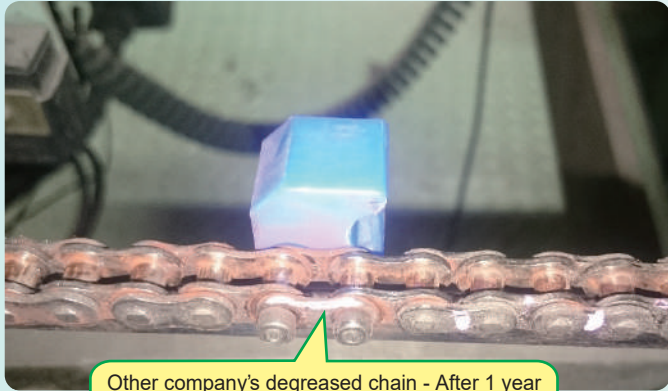
Other company's degreased chain - After 1 year

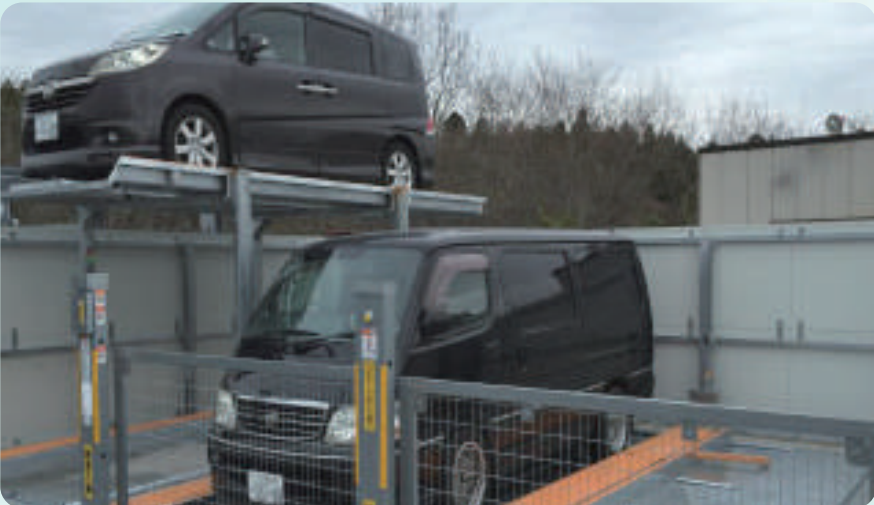
In the multi-story car park, the chains were used outdoors, where they were exposed to high humidity with rain, mud, dust, etc.

Outdoor multi-story car park

The TLH Roller Chain did not rust after 26,000 hoisting test cycles (outdoors) for 8 months.

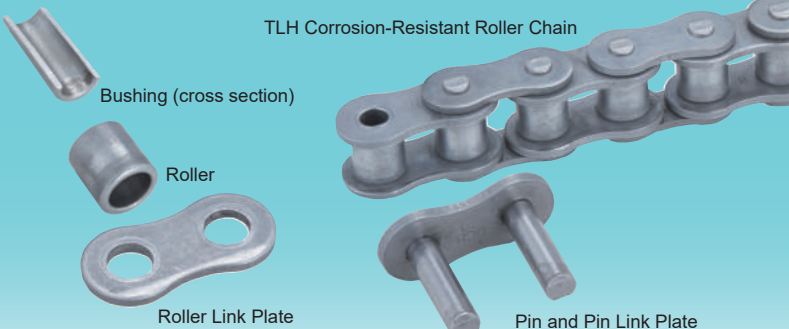
Chain Parts After Use (After Washing)

TLH Corrosion-Resistant Roller Chain

Bushing (cross section)

Roller

Roller Link Plate

Pin and Pin Link Plate
